Manhole Inspection Summary

Manhole # S23A__024MH

Insp Date: **7/30/07 8:22 AM**

Location Address: **BEHIND 713 CALHOUN ST**

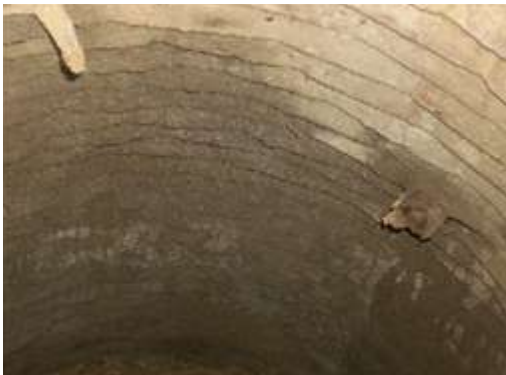
Defect 3

Infiltration: ☐ None ☐ Joint ☐ Cracks ☐ Mortar ☐ Roots ☒ **Wall**

INFILTRATION OF CORBEL

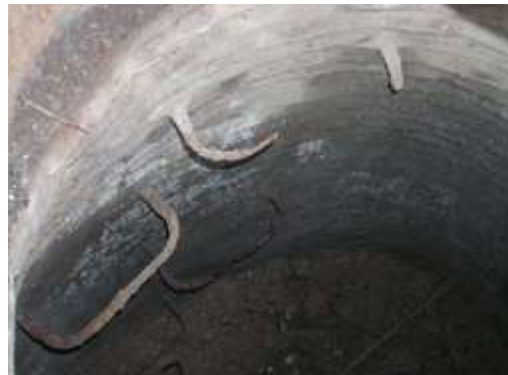
Defect 2

Count: **2** Missing: **1** ☒ **Corroded**

MISSING AND CORRODED STEPS

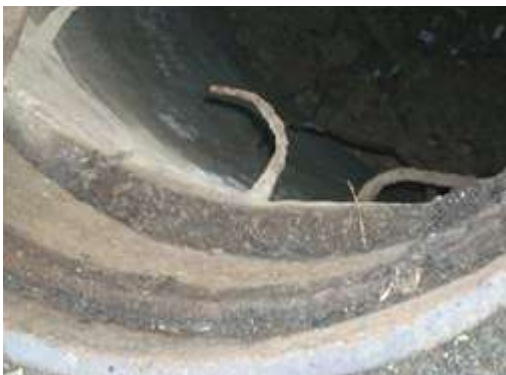
Defect 1

Offset: **2** (in.)

FRAME OFFSET

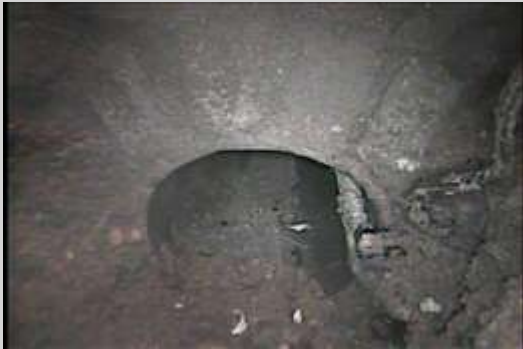
12 O'Clock Outflow

Deposits: ☐ None ☐ Mud ☐ Sludge ☒ **Debris** ☐ Grease

Silt Depth: **1** (in.) Deposits Extent: **Light**
